## Borehole at Coates Lock March 2025

**Borehole location**

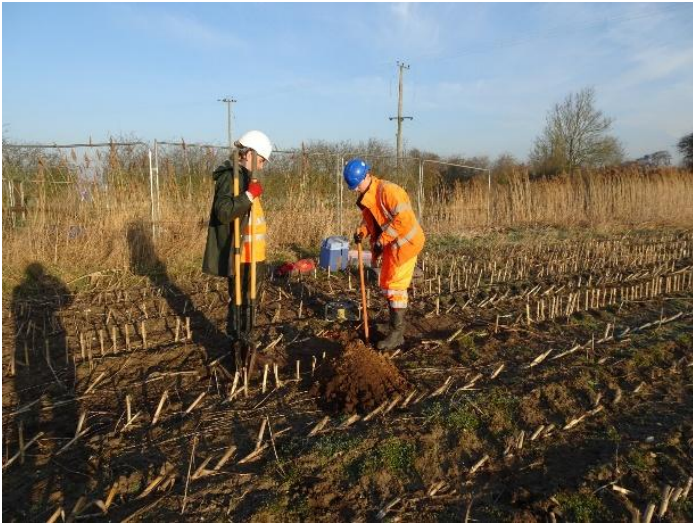
Shone Geotechnical arrived on site on 20 March at 6:30am to scan the site for underground pipes and cables. A confirmatory pit was also hand dug at the site of the borehole.

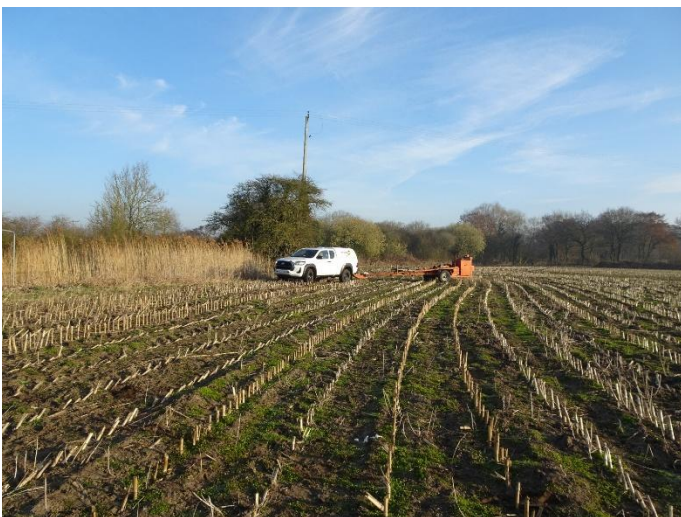
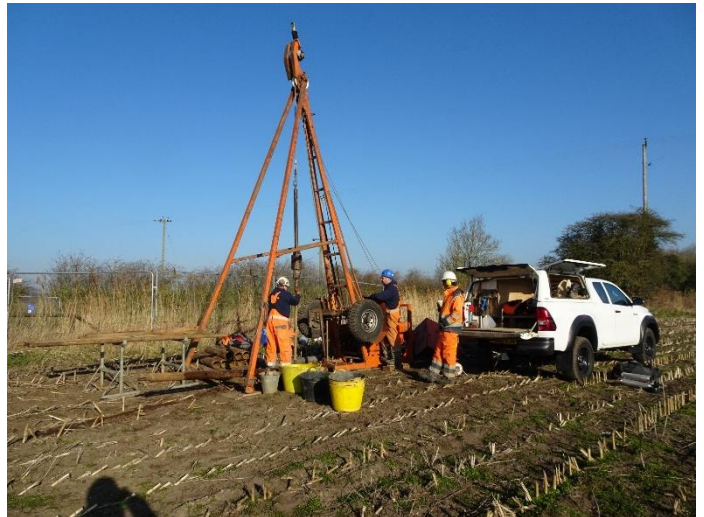
The drilling rig arrived at 7:00am and set up ready to start drilling.

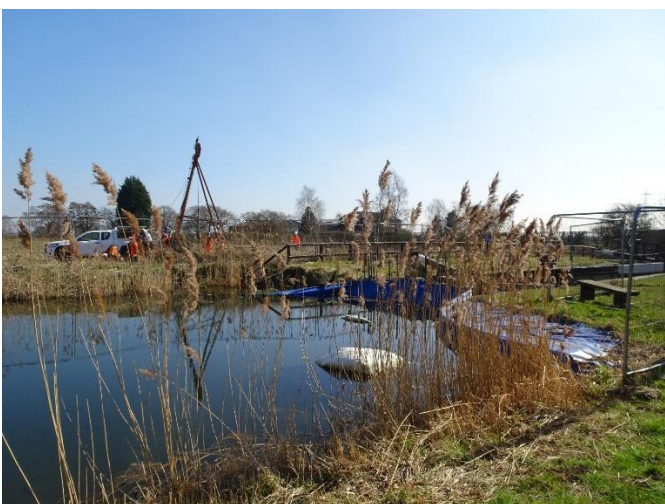
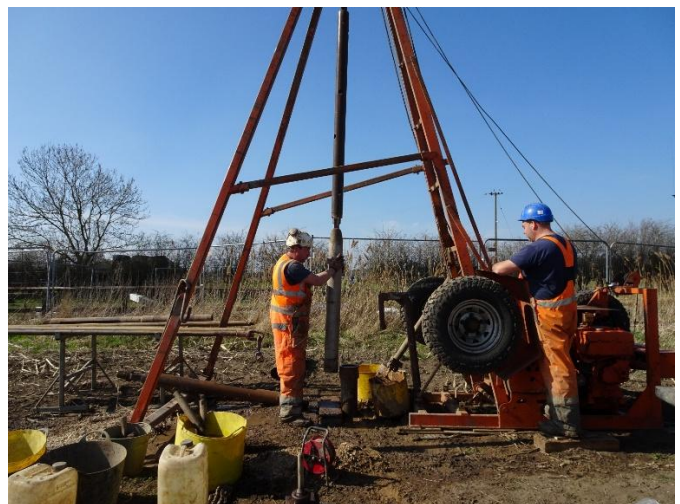
The work continued for most of the day and reached a depth of 9.3m below the ground surface.

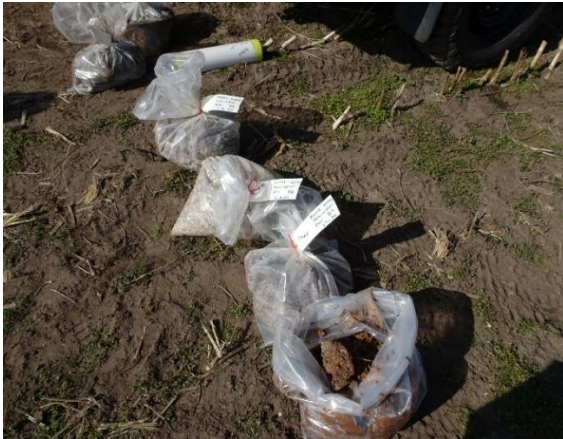
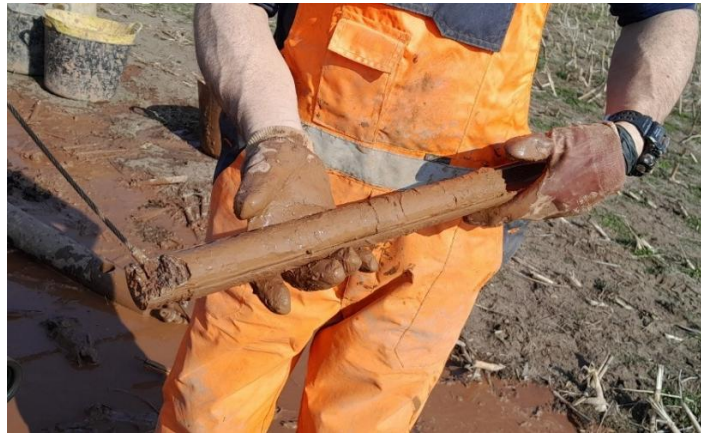
Representative samples of the soils that were encountered were taken and down-hole tests performed.

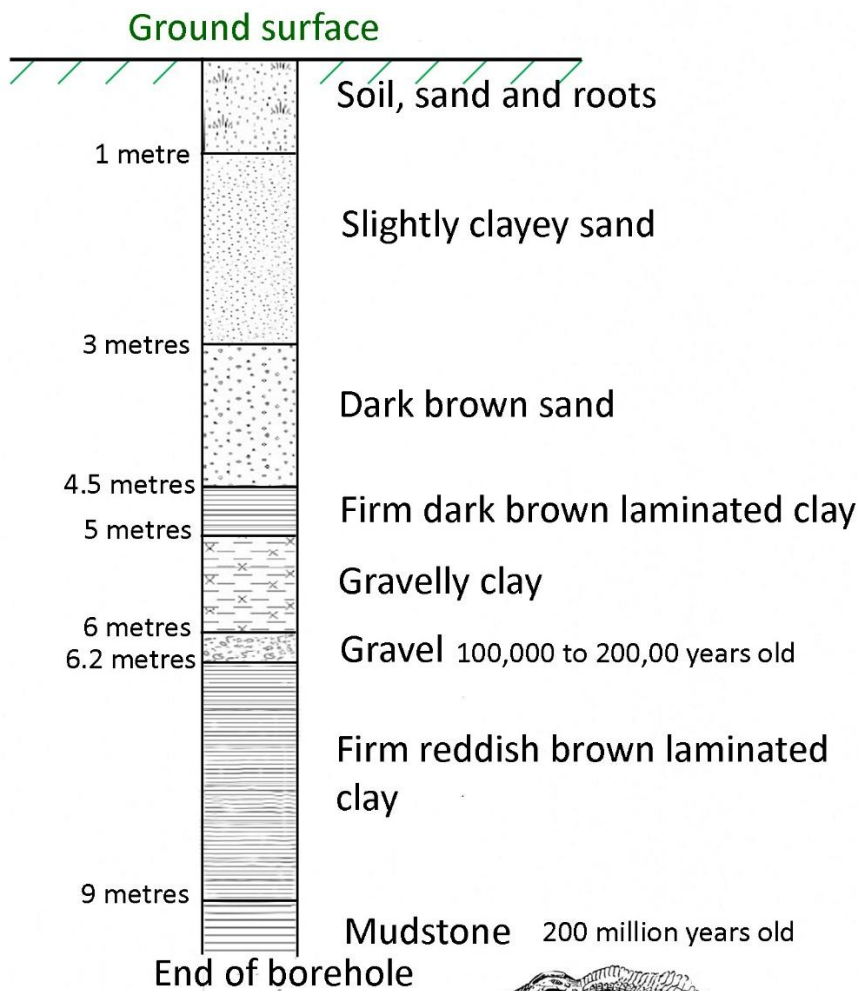
The borehole passed through a variety of soil types, including sands, clay and gravel before terminating in the underlying solid geology which is Mercia Mudstone.
